**Flood Control Project Maintenance
Levee Inspections**

Maintenance Issue Types Only, Levee Inspection Report By Mile - Fall 2018

Reclamation District No. 0755 Randall

Waterway	Bank	Unit Miles	Inspection Start/End	Inspector
Unit No. 01 Sacramento River	Left	1.83	10/05/2018 10/05/2018	David Julian

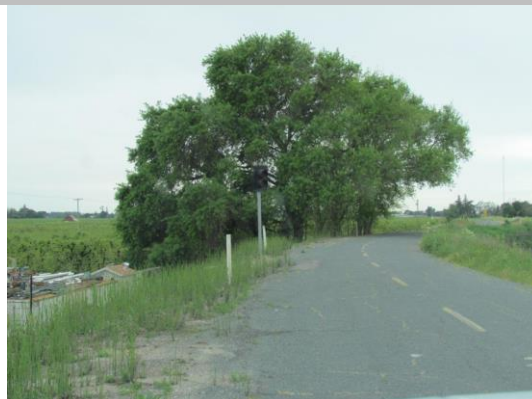
Photo 2 of 2 : FA_2018_RD0755_177_20_20180925_00007.jpg

RD 755 looking downstream from levee mile 0.17-0.59.

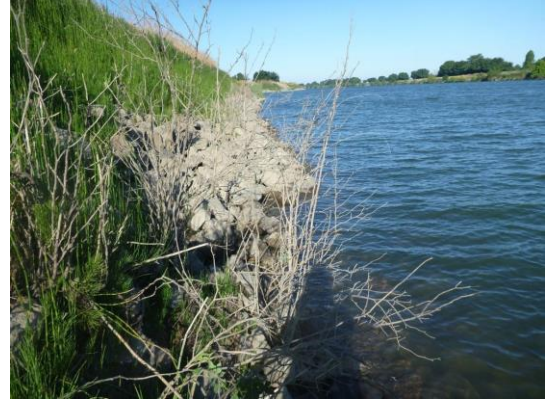
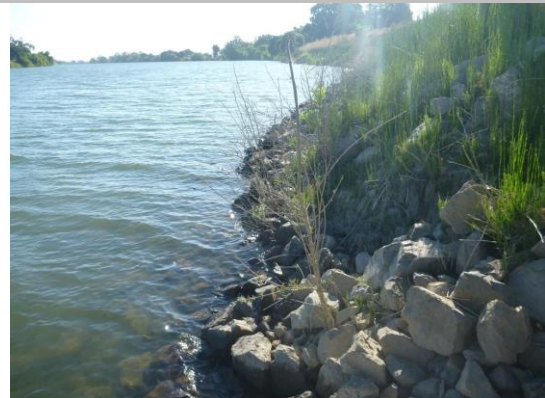
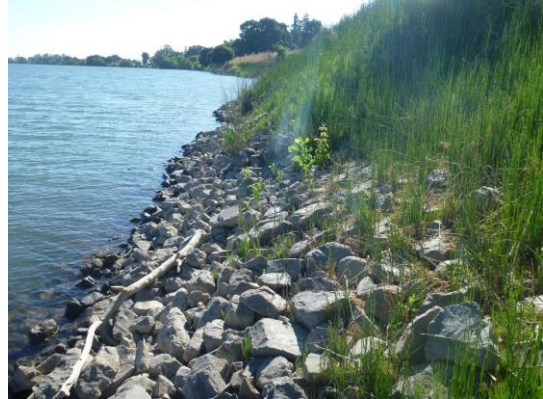
Comment Code					
Inspector Comment					
Levee Evaluation Comments					
Description:The damage consists of erosion of the lower waterside levee slope and bank approximately 27 feet in length along the east (left) bank of the Sacramento River. See attached pages for photos. Site location T06N R04E Section 28.					
Site ID No:327					
Site Designation:LMA-154					
Repair Type: Erosion					
Rating:Area of Concern					
Field Date:7/13/2017					
Notes: Pretty minor damage visible from the slope, site was originally identified by boat. Will look at again from waterside if there is time.					
Crown is a paved road. Original GPS was a little off, added correct point in start

Comment Code					
Inspector Comment					
<p>Levee Evaluation Comments</p> <p>Description: The damage consists of erosion of the lower waterside levee slope and bank approximately 27 feet in length along the east (left) bank of the Sacramento River. See attached pages for photos. Site location T06N R04E Section 28.</p> <p>Site ID No: 327</p> <p>Site Designation: LMA-154</p> <p>Repair Type: Erosion</p> <p>Rating: Area of Concern</p> <p>Field Date: 7/13/2017</p> <p>Notes: Pretty minor damage visible from the slope, site was originally identified by boat. Will look at again from waterside if there is time. Crown is a paved road. Original GPS was a little off, added correct point in start</p>

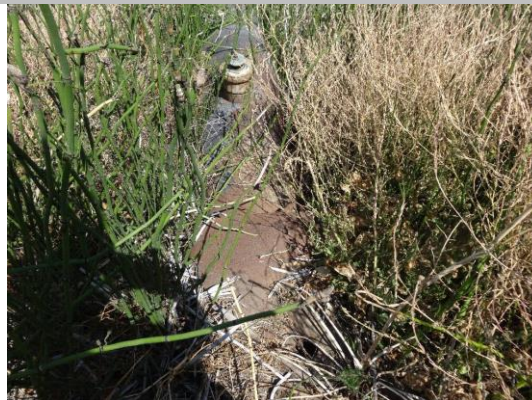
Photo 1 of 3 : UCIP_FA_2018_17145_29292.jpg

Comment Code						
Inspector Comment						
FS_ID:17145 DS_ID:18852 EP_NO: 11222 Repair Type: No Action Needed Crossing Status: Found UCIP Comments: It was working during field survey. A pump found 150 ft from the levee. Not sure whether the pump belong to this drainage system. FIELD_STRUCT_DESC: *ABANDONED* 16-inch steel drainage pipe sleeved through a 24-inch steel drainage pipe through the levee, invert elevation 8 feet below the crown. (Retention of a 12-inch drainage pipe sleeved through a 24-inch pipe through the levee, 8 feet below the crown, authorized under Automatic Board Order (ABO) issued as Permit No. 11222, 1975 - Green McKeown, Inc). [Additional Reference(s): DWR Levee Log, 2005, 12-inch inner pipe referenced. USACE Sacramento O&M Manual 111, May 1959, (RM 35.89)]. FS Date: 8/6/2013

WS view: pipe and siphon breaker on levee slope

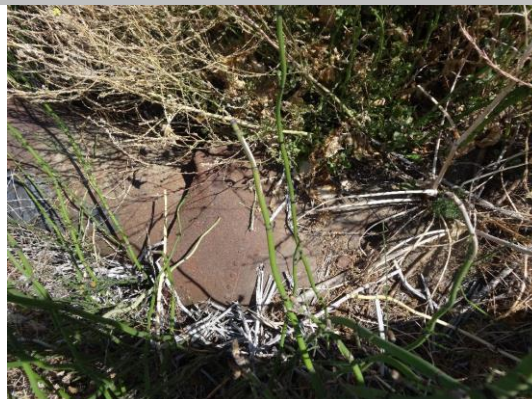
Photo 2 of 3 : UCIP_FA_2018_17145_29293.jpg

WS view: 16-inch pipe sleeved through 24-inch pipe.

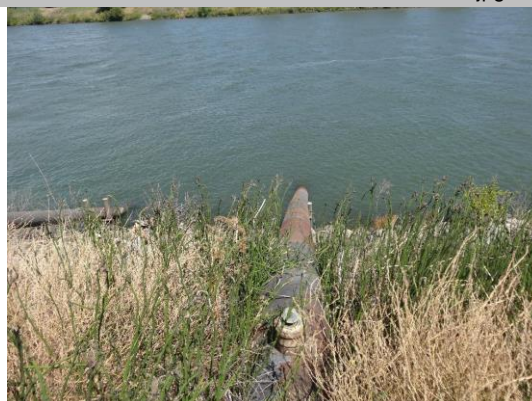
Photo 3 of 3 : UCIP_FA_2018_17145_29295.jpg

WS view: 16-inch drainage pipe on levee slope.

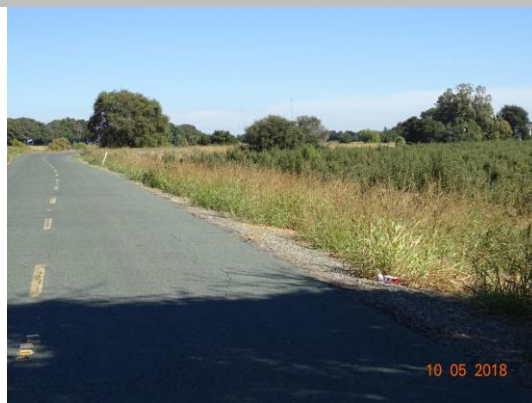
Photo 1 of 1 : FA_2018_RD0755_177_28_20181009_00042.jpg

LM Start	1.12	Rating **	M	Issue No.	28
LM End	1.42	Issue Type +	Ma	Location *	LS
Category	Earthen Levee			GPS Latitude/Longitude	
				Start	End
Item	Vegetation			38.343300 °	38.341237 °
				-121.555507 °	-121.560113 °
DWR ID	DWR_RD0755_01_s_2017_28				
Comment Code					
V1 : Control annual grass and weeds on the levee slopes and easements.					
Inspector Comment					
Remove vegetation from land side slope.

View looking upstream at vegetation on the land side slope (October 2018).

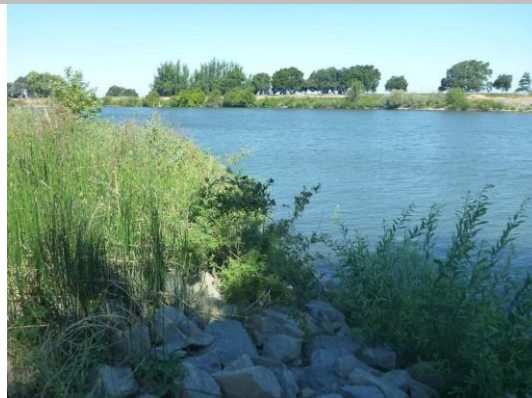
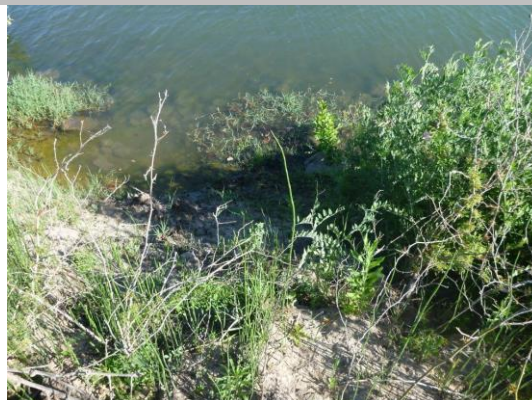
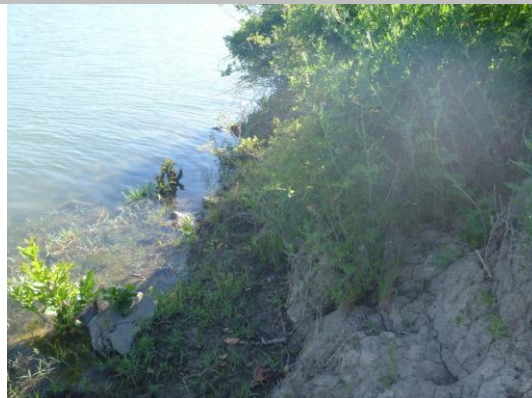
Description: The damage consists of erosion of the lower waterside levee slope and bank approximately 322 feet in length along the east (left) bank of the Sacramento River. See attached pages for photos. Site location T06N R04E Section 29.

Notes: Could not access most of the lower portion of the slope because of vegetation, but there was rip rap just downstream of the site. Looked like it may have been missing on part of the site. Erosion looked like it may be 1/2 the length reported. Crown is a paved road
